Ambient Groundwater Quality of the Douglas Basin: An ADEQ 1995-1996 Baseline Study

---Douglas C. Towne
Maps by Larry W. Stephenson
ADEQ Fact Sheet 00-08
September 2000

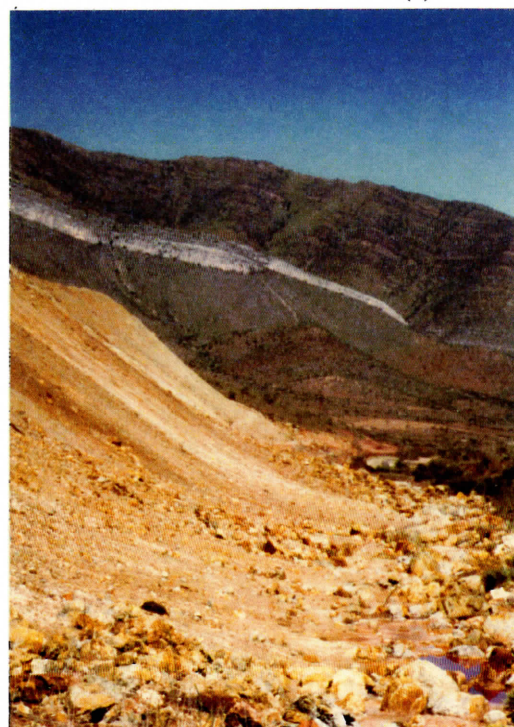
Figure 7. Mine tailings near Mule Gulch appear to contribute to the elevated sulfate levels found downgradient of Bisbee.

Mine tailings appear to be contributing to elevated groundwater sulfate levels found along Mule Gulch, downgradient of the town of Bisbee (Figure 7). Sulfides in these tailings are oxidized to yield sulfate that is soluble in water. A site near where Mule Gulch enters the alluvium of Sulphur Springs Valley had a sulfate level of 1330 mg/l, exceeding the 250 mg/l Secondary MCL. Further downgradient, sulfate levels rapidly decreased. Elevated sulfate levels due to mine activities have been found south of Bisbee near the town of Naco (4).

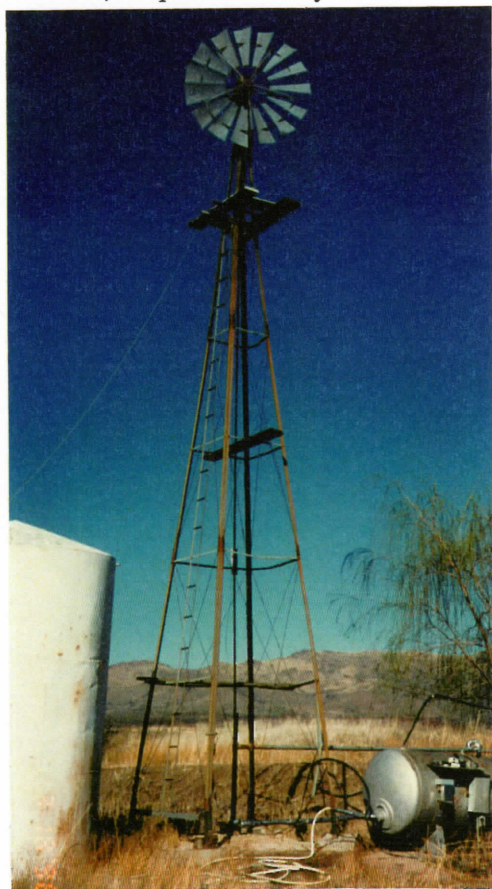
Figure 8. Windmill pumps water into a storage tank by the Pedregosa Mountains.

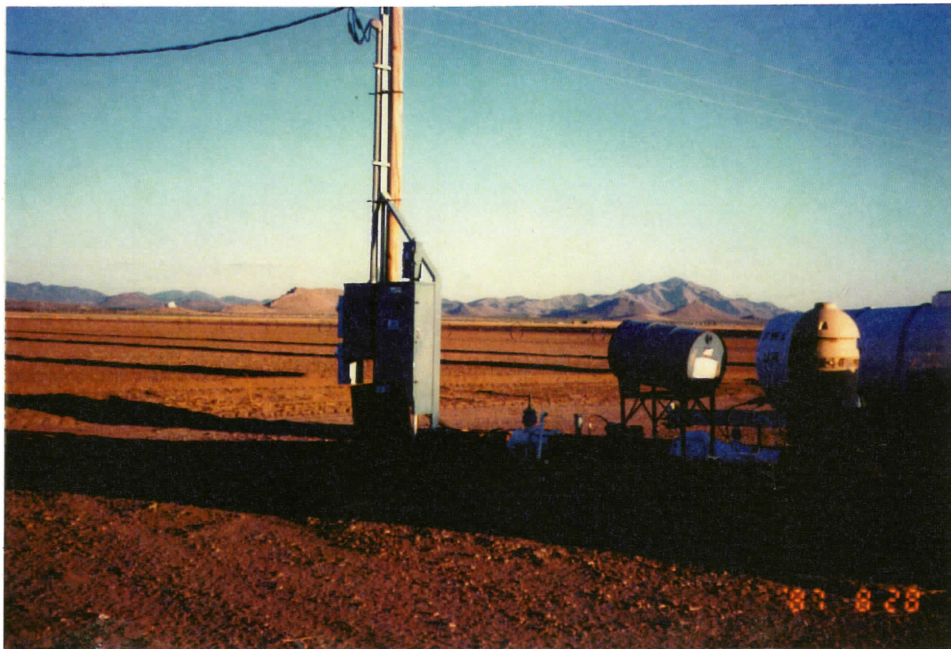
Figure 9. Farmland, irrigated by groundwater pumped by the turbine well in the foreground, lies fallow after fall harvest north of the town of Elfrida.
